Resurrecting Sleeping Giants Rebuilding the Maple Grove Lime Plant

By C. A. Shaw P.Eng.
Ferenco

Project Manager for the Carmeuse Maple Grove Project

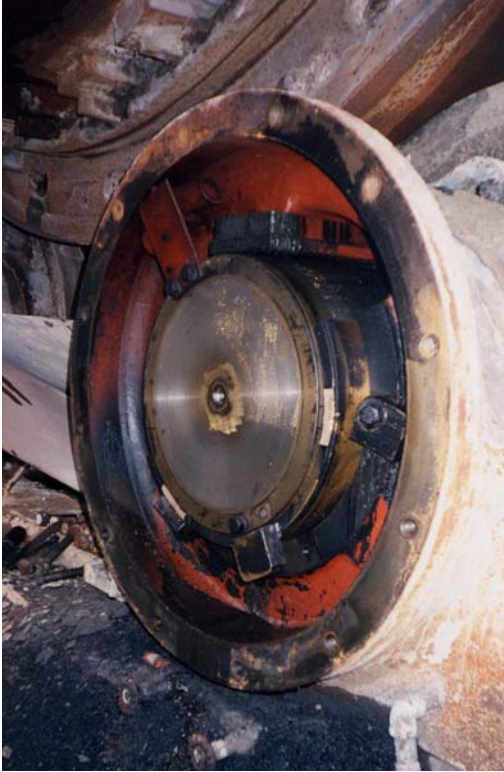
Photo #2 - Condition Survey of Kiln Trunnions

At Maple Grove, equipment was both reused and replaced. The most obvious pieces of equipment that were reused were the kilns. Each kiln is eleven foot three inches in diameter by three hundred ninety feet long. A survey of the two kilns was conducted along with an alignment check to verify the condition of the tubes. The survey included a complete review of the drive train. The kiln one girth gear was in poor condition but the pinions were good. Kiln two had poor pinions but the girth gear was in usable condition. Fortunately there was a spare girth gear purchased years ago lying in a field at the far end of the plant. Consequently, the kiln one girth gear was removed and replaced with the spare gear. Kiln one also received new pinions. The pinions that were removed from kiln one were installed on kiln two and the existing girth gear was cleaned and inspected. All the gearboxes were rebuilt and every kiln trunnion was shop repaired with new seals installed.

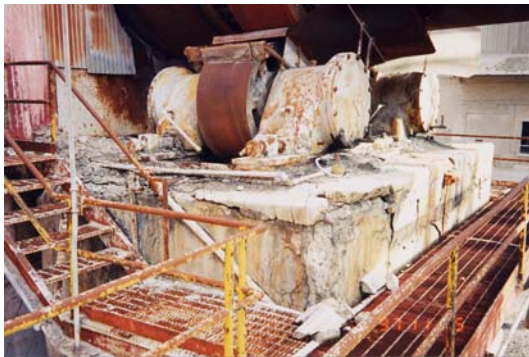
During the early stages of the survey, it was observed that the concrete around the plant was crumbling and primarily the kiln piers. There was a brown/yellow stain to many sections of the concrete suggesting that the rebar was deteriorating from within the concrete. Large pieces of concrete had fallen off and if the concrete was hit with a hammer, a hollow sound could be heard.

Photo #3 – Kiln Pier Concrete Degradation

It was determined that this problem was serious enough to engage a specialist to examine the concrete and to advise what possible repair could be done. During the site visit each face of the kiln piers, which were the worst concrete problem by far, was mapped out in a grid pattern. A copper-copper-sulphate half cell potential survey was conducted for each pier face. From this data it was possible to determine whether corrosion was taking place. The conclusion was that significant problems lay beneath the surface.

The initial repair method selected was to chip away the delaminated concrete, repair the rebar mat, and reface the piers with shotcrete. A contractor was hired with the experience necessary to complete the work both professionally and in a timely manner, as the kiln work could not effectively begin until the work was completed. During the repair work however two of the piers were far worse than expected, to the point if the removal process proceeded any further the structural integrity of the pier would be compromised. It was decided at this point that the repair method had to change to one of forming a concrete jacket around the pier. This method was, by no means, easy. High forces from the pour of high walls around the pier deflected the forms and caused a slight bow in the first wall. However on the remaining wall the form bracing was increased dramatically thus minimizing the deflection of the form. The concrete repair work took at least four months to complete.

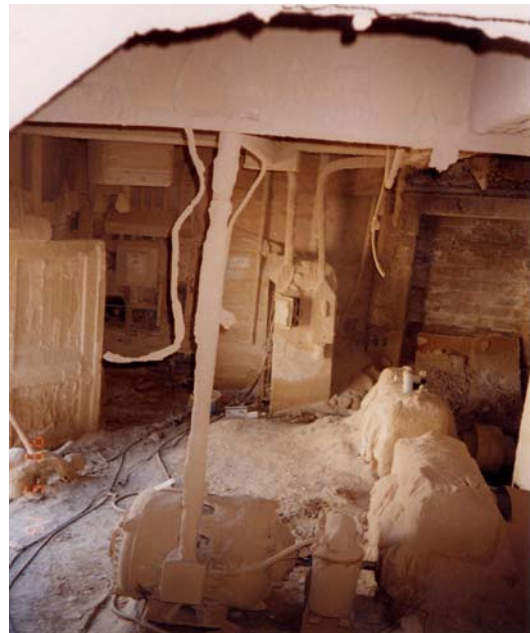
The demolition contract for this project included cleaning as well. Given the condition of the plant when construction began, lime deposits in all the tunnels and passage ways, debris, other materials stored in the silos, and remaining, lime/limestone and brick in the kilns had to be removed from the work area.

Photo #4 – Plant Condition before Cleaning

The silos had to be cleaned by cutting holes in the concrete sidewalls. The new equipment at that time was not installed and the old equipment was of no use as the silo material did not flow anymore. Augers mounted on bobcats were used to work their way into the material from the side, while a team from above used a proprietary "mole" device from above to dislodge the old material. The process of cleaning the silos took at least 3 months. When completed access doors were placed on the sides of the silos, in the event they ever had to be cleaned again.

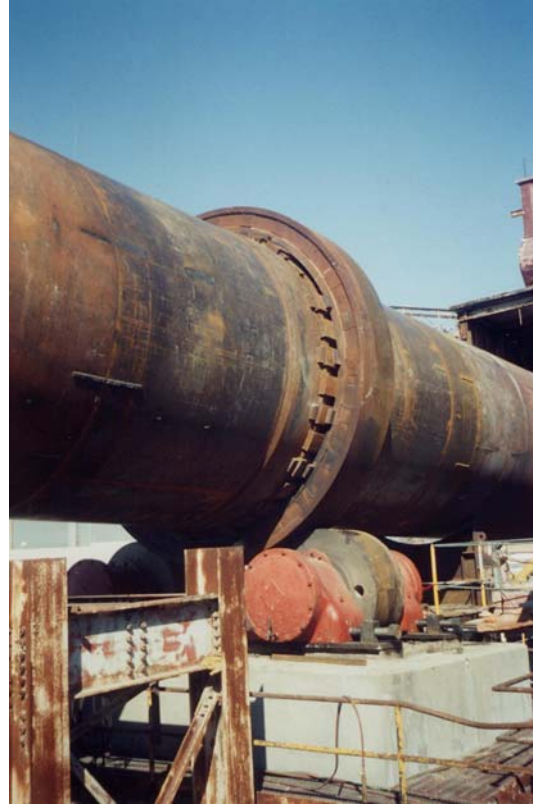
The shell sections of both kiln one and two needed work. The feed and discharge ends of the kilns were replaced. Additionally some other sections of the kilns were replaced including two heavy tire sections.

Photo #5 – Installation of New Kiln Shell Section
